CRITICAL AREAS REPORT AND MITIGATION PLAN

BRIDLESTONE ESTATES

4626 116TH AVE NE

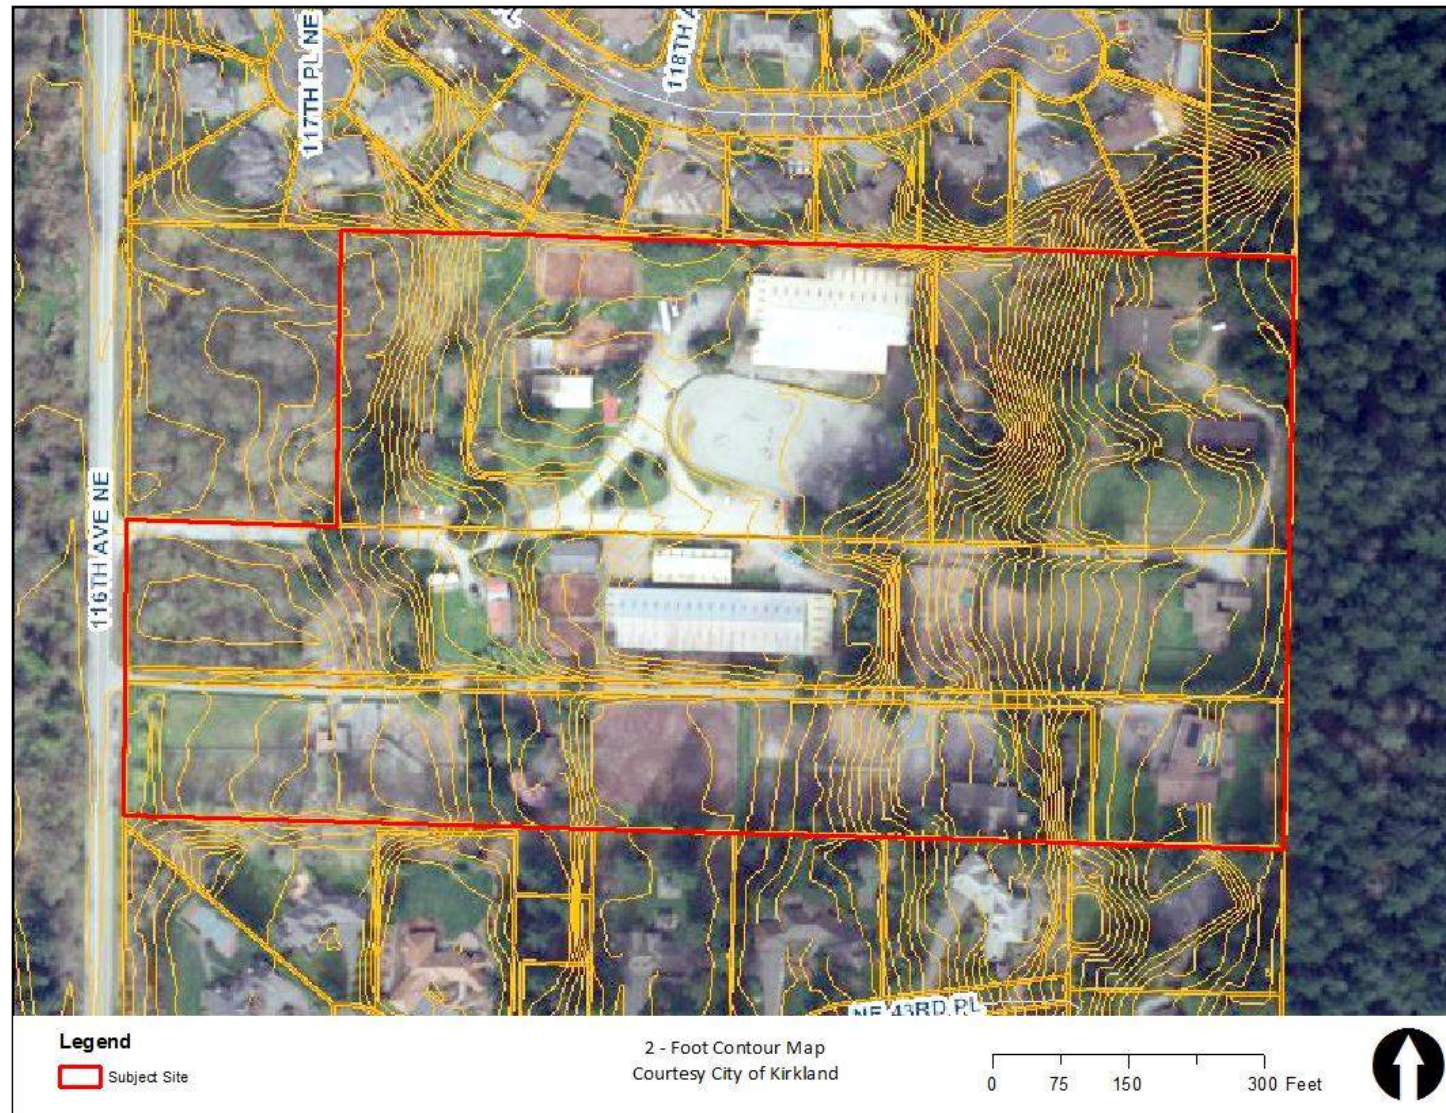
Figure 4: Topographic map of the project site.

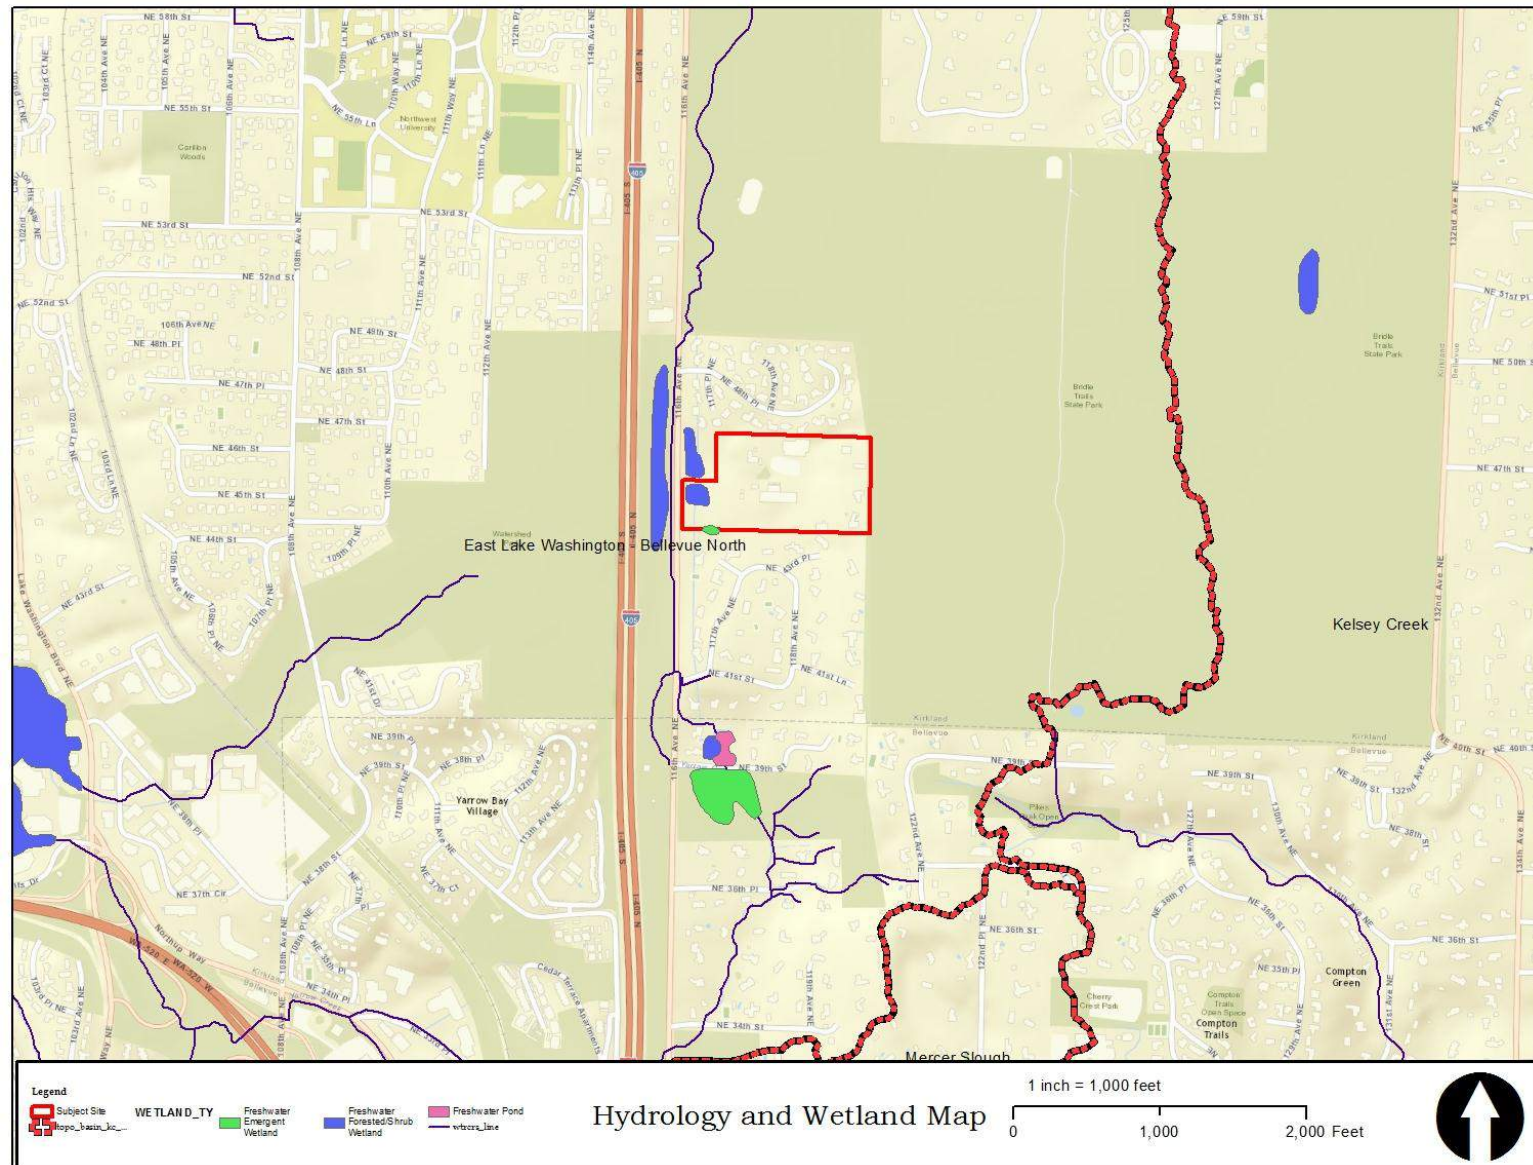
Figure 5: Watercourse and Wetland Map.

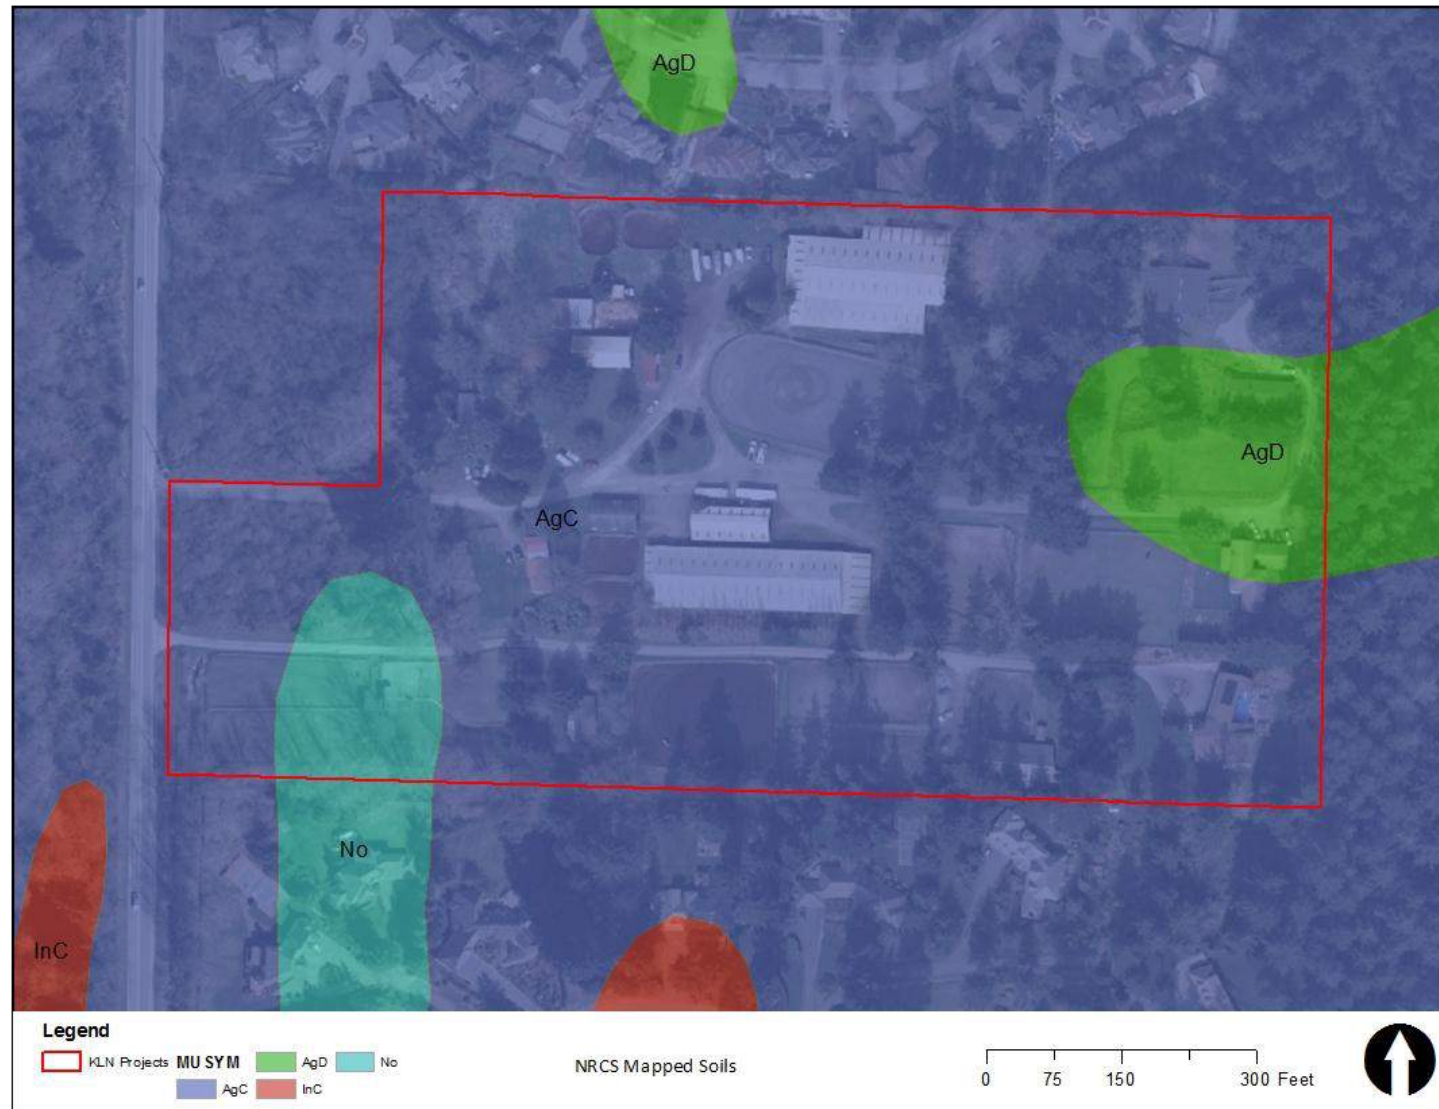
Figure 7: NRCS soil survey of the project area.

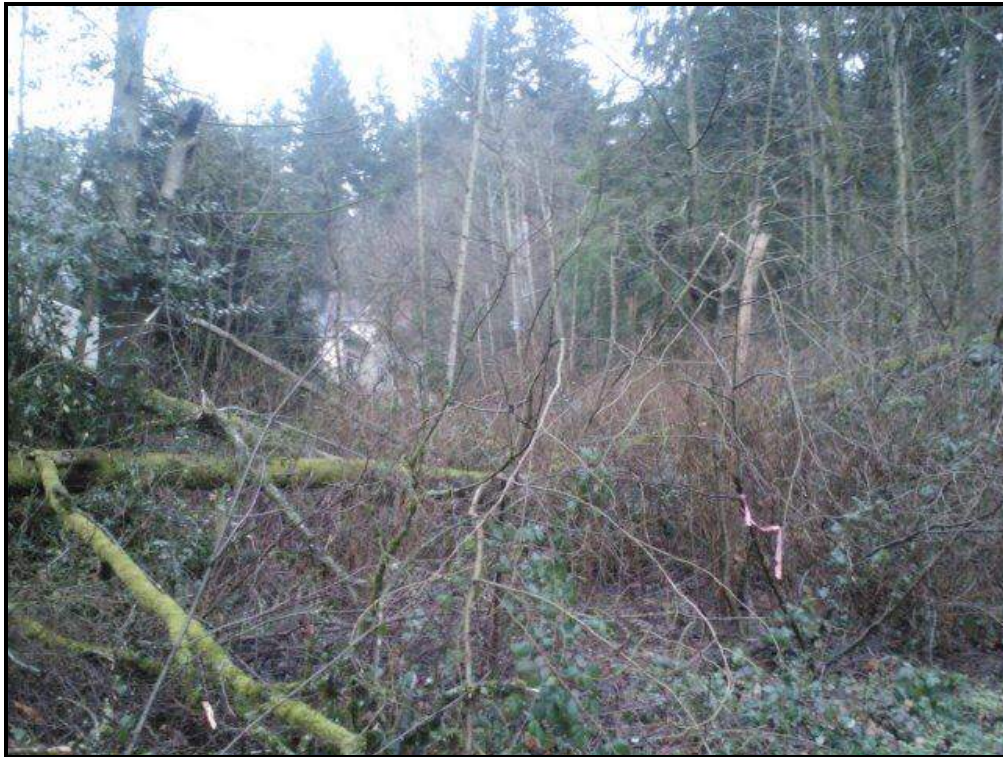
Figure 8: Existing conditions of Wetland A facing north off-site.

Wetland A provides moderate overall functions and values based on the size, location, and condition of the wetland system. Wetland A provides very good habitat and refuge for local wildlife. The wetland corridor connects to the Bridle Trails State Park, which is forested with mature trees and shrubs. The wetland provides low to moderate stormwater control functions, with limited area available for storage and detention. Wetland A provides moderate to high water quality improvement functions based on the opportunity (surface runoff received residential and agricultural sources) and ability to filter and infiltrate water with the existing vegetation and soil characteristics.

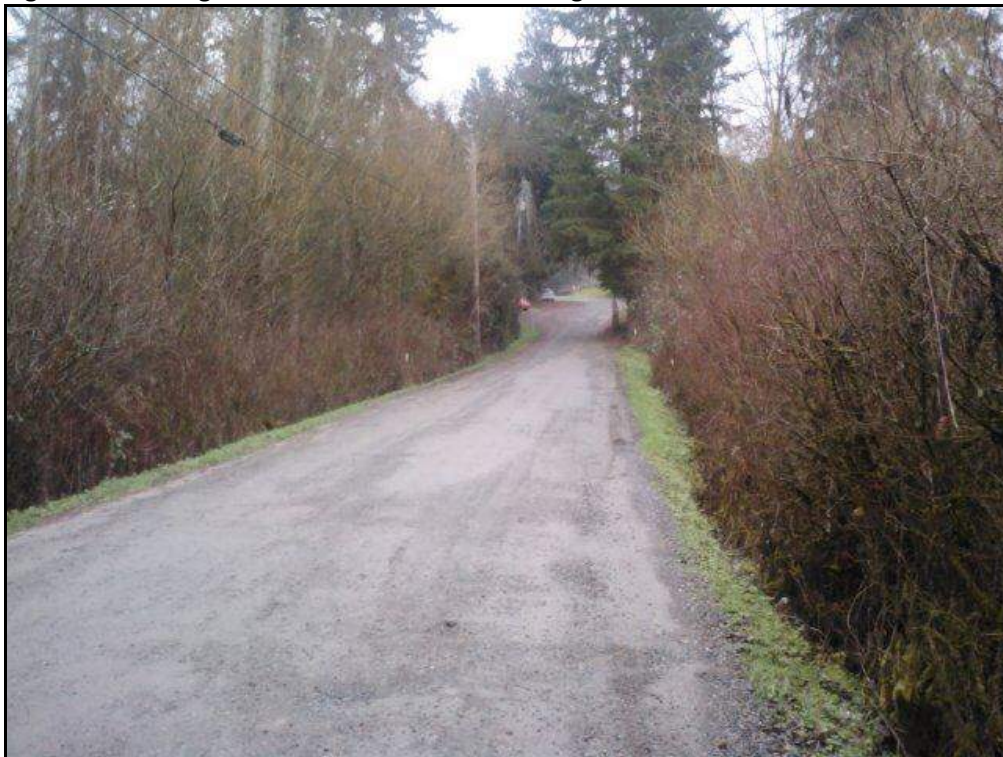
Figure 9: Existing vegetation gravel road bisecting Wetland B – wetland re-establishment area.

The wetland re-establishment area located where the existing northern access driveway will provide a net increase of existing wetland area on-site. The mitigation measures in this area will provide an excellent opportunity to connect a fragmented habitat and remove regular disturbance. The existing gravel road bisects wetland area and limits habitat functions within this area. The road is also a conveyance of impaired surface water runoff that includes turbid water (observed during site investigations) and water that is likely high in nutrients (assumed) due to local sources.

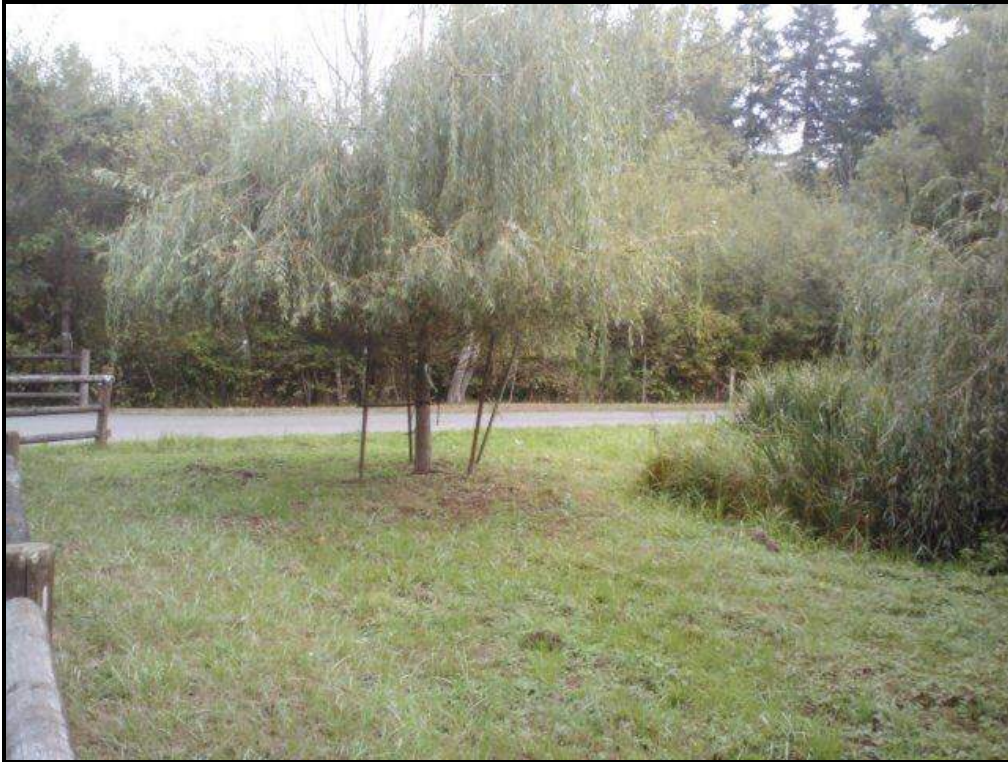
Figure 10: Existing vegetation community Wetland C facing north towards proposed road impact area.

Wetland C provides low to moderate overall functions and values based on the size, location, and condition of the wetland system. Some of the existing factors that negatively influence the functions and values include the lack of a functional buffer along the western boundary, fragmentation from existing access driveways through the wetland, and encroachment from equestrian activities to the east. The majority of buffer area on-site has been severely impacted from past clearing and grading and current livestock use.

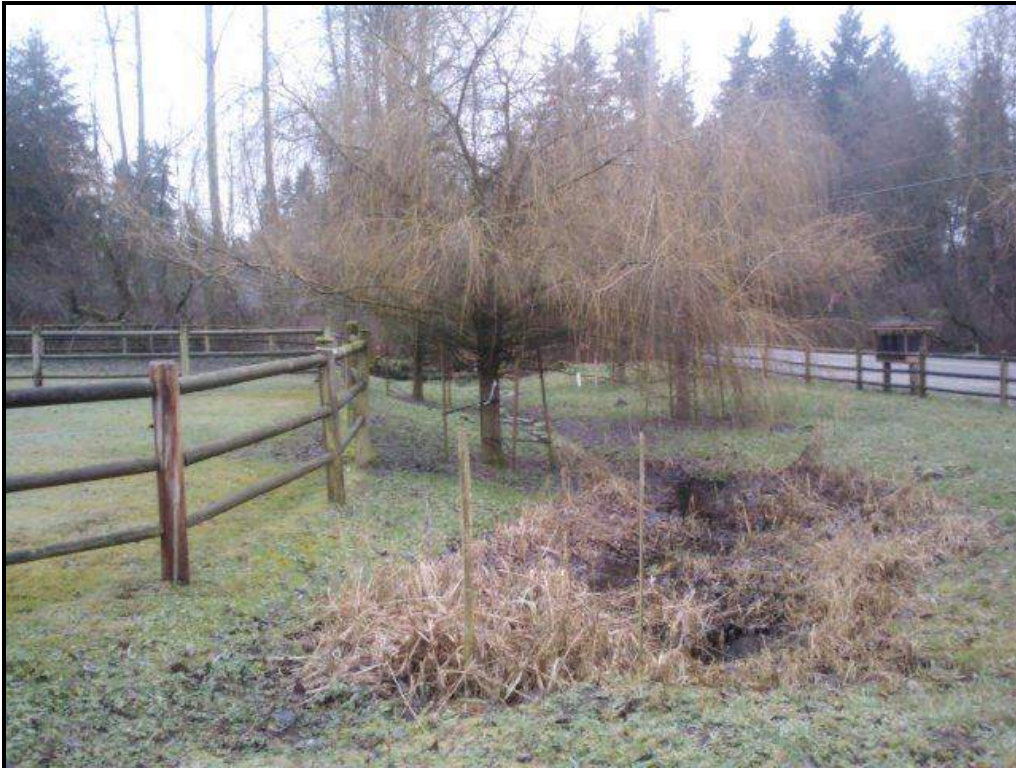
Figure 11: Existing vegetation community Wetland C facing south near proposed road impact area.

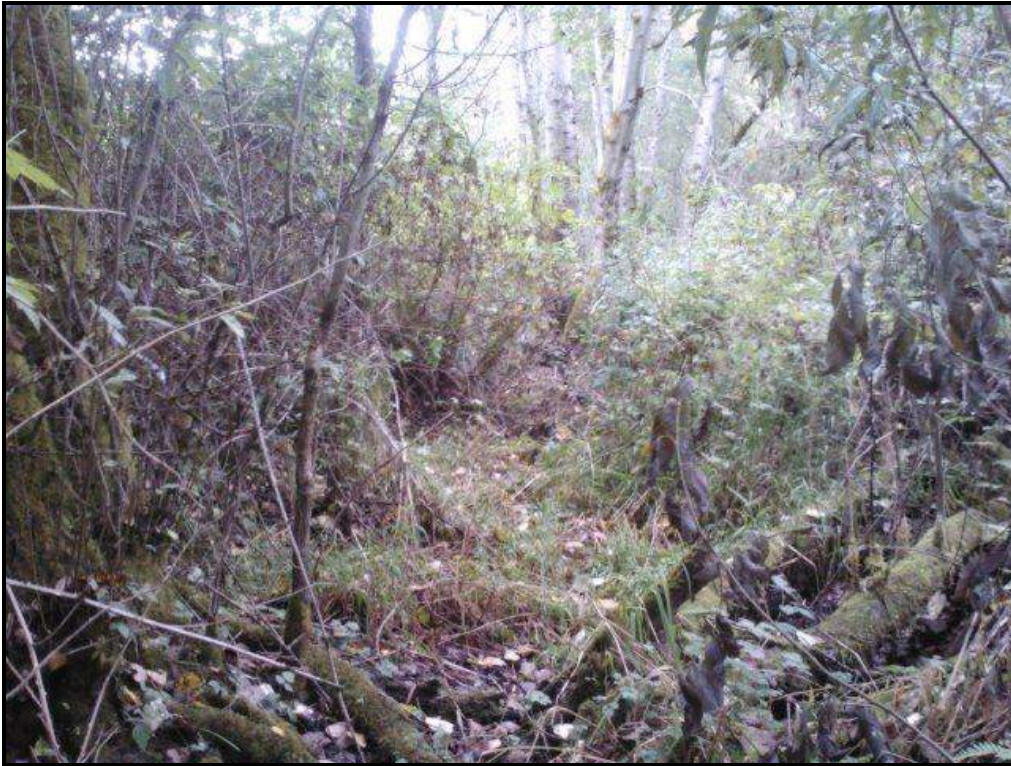
Figure 12: Off-site Wetland C connection.

Yarrow Creek and associated Wetlands B and C continue off-site to the north and south. Wetland A extends off-site to the north and northeast. The off-site areas have been identified on the critical area map in Appendix A. These areas appear to be largely defined by the existing topography. Additional wetland areas have been observed on the west side of 116th Ave NE adjacent to the subject site. No other wetland or streams have been mapped within 300-feet of the subject site.

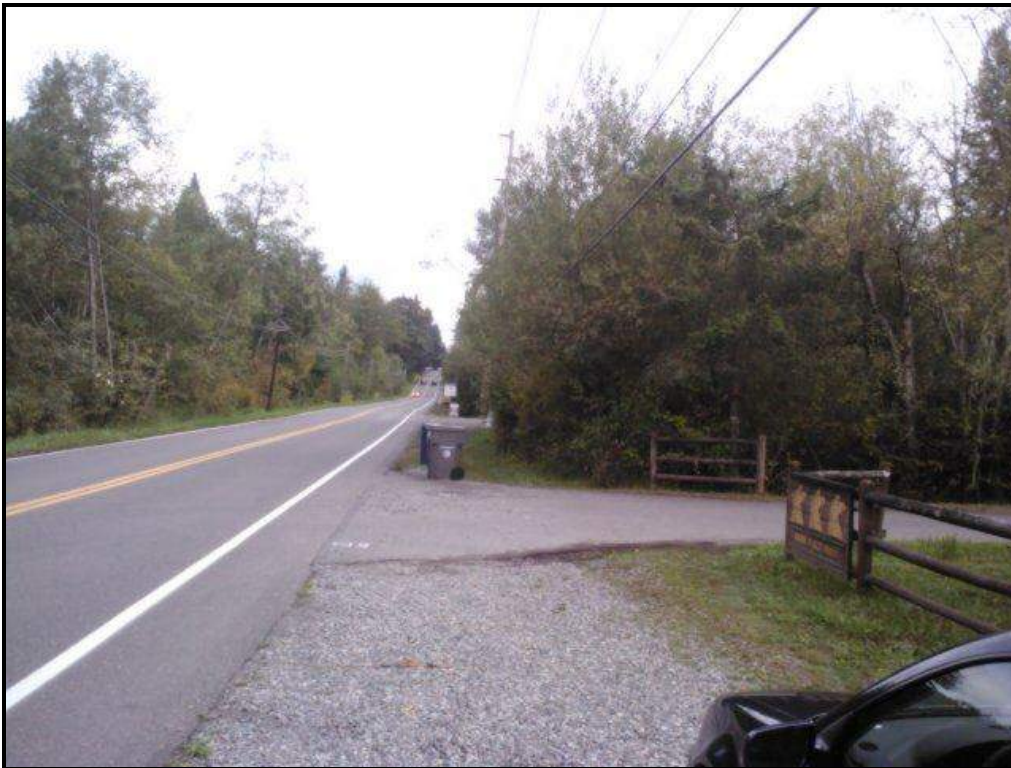
Figure 13: Existing road frontage conditions facing north along 116th Street

As discussed in the critical areas study and mitigation plan, the existing buffer is degraded. The on-site buffer has a paved driveway and fenced horse pasture, with no tree and shrub vegetation present. The horse pasture is overgrazed and provides little to no functional support for the adjacent wetland and stream area.
